**PAKISTAN**  
**WATER AND POWER DEVELOPMENT AUTHORITY**  
**ATTABAD LAKE HYDROPOWER PROJECT**  
**FEASIBILITY STUDY**

**VOLUME 3**  
**GEOLOGICAL AND GEOTECHNICAL**  
**STUDIES**

June 2021

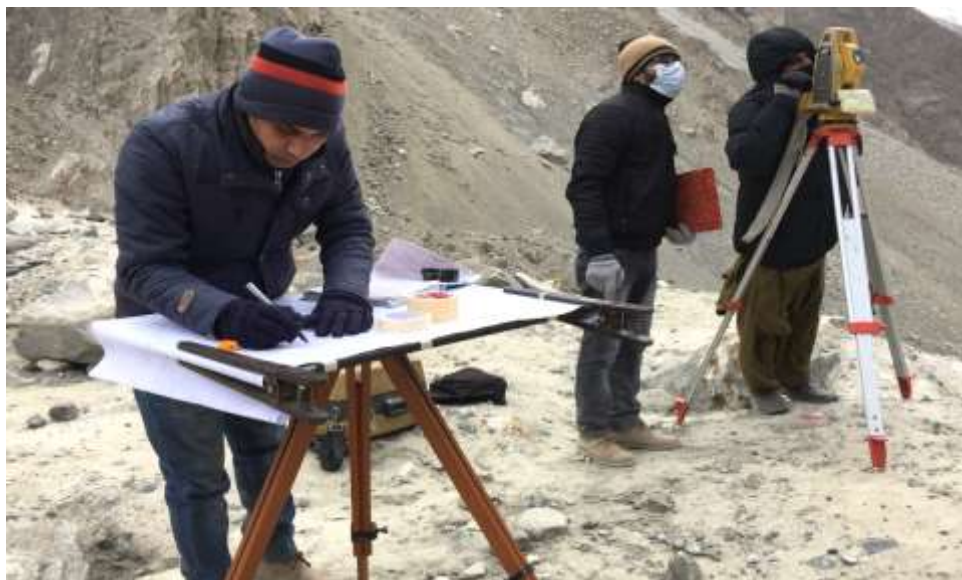
**Photo 4-1 Surface Geological Mapping**

The Surface geological mapping of the Project Area has been carried out on 16 topographic sheets prepared by Survey Division Peshawar, HPO, WAPDA on scale 1:1000 with contour interval of 2 m, with the help of Total Station, Plane Table and Brunton compass and presented at scale of 1:2000 (**DWG No: AFS-GE-293 to 312**). The contacts between different rock units e.g granitic gneiss and granodiorite as well as between different soil units have been marked. Structural features like joint sets, faults, foliation and shear zones along with dip and strike values have been marked on these sheets.

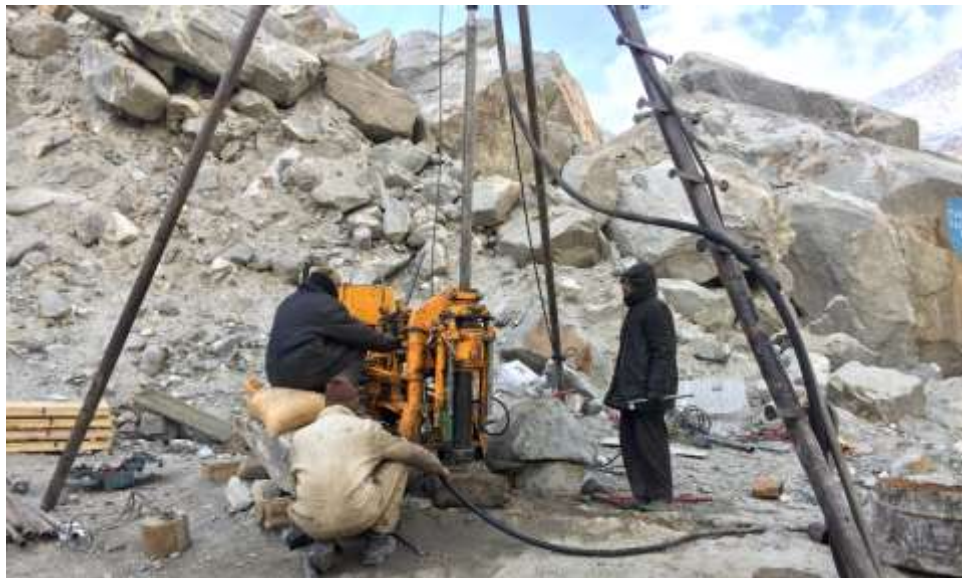
**Photo 4-2 Drilling Rig at BH-02 Sediment Flushing Channel .**

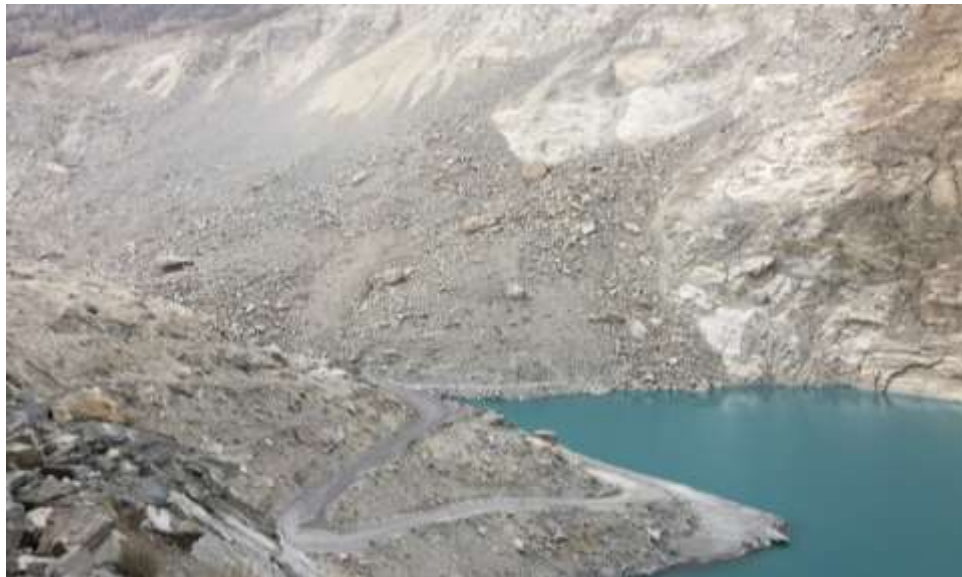
**Photo 6-1 A View of Weir Site.**

An overtopping concrete weir founded on slided mass is proposed after foundation treatment. Geological rock units with which weir has to be abut, includes granodiorite, intruded by pegmatite veins at right side. On left side, weir has to be abut with ABGM formed by slided mass **(DWG No: AFS-GE-297 & 298)**. Some treatment / engineering solution have to be implemented for stability of the weir **(Photo 6-1)**.

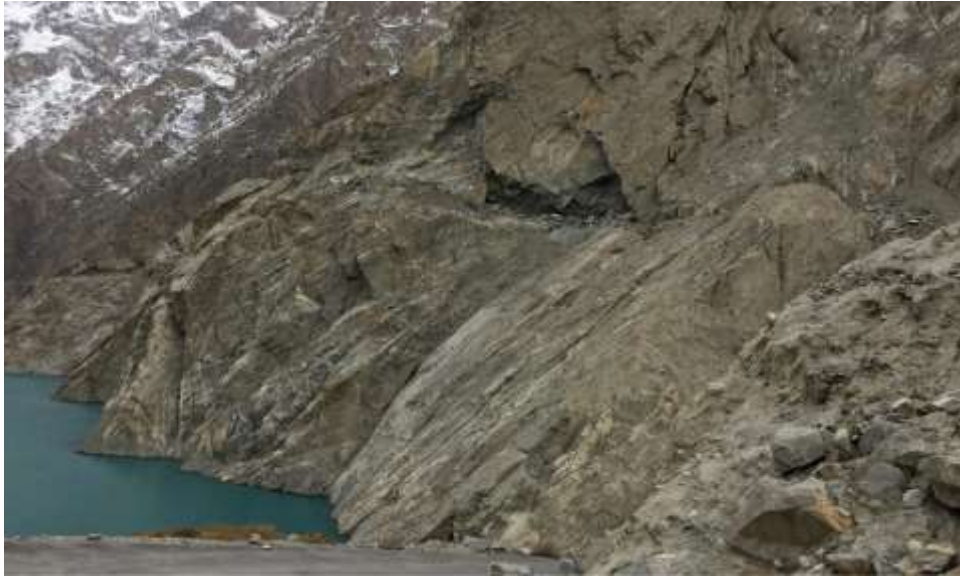
**Photo 6-2 Proposed Intake Area for Power Tunnel**

Granodiorite rock is hard, strong to moderately strong, and sparsely to moderately jointed (**Photo 6-2**). But at higher elevation, the rock is highly jointed and sheared, having vertical open joints which must be treated for stability and safety.

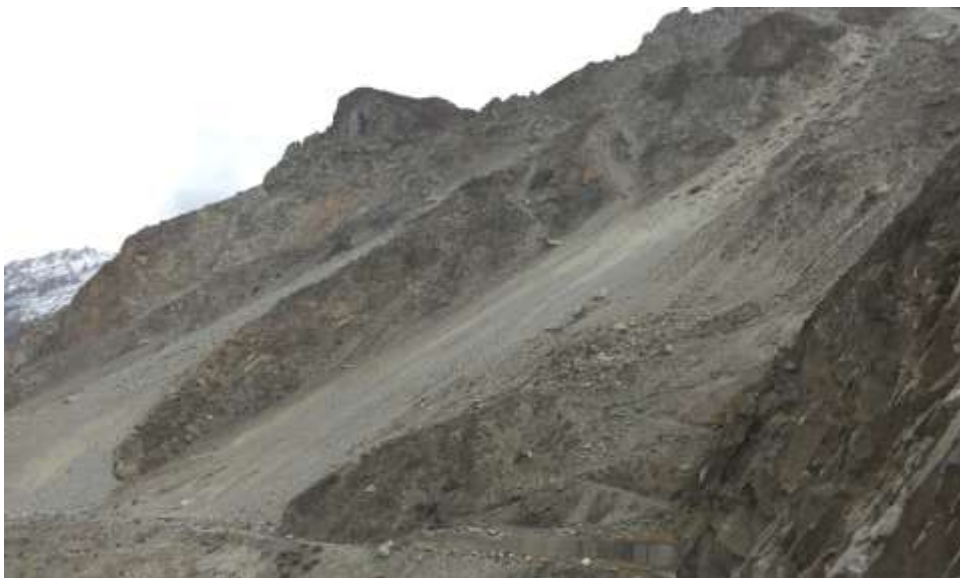
**Photo 6-3 Rolling down of Scree along Active Slide**

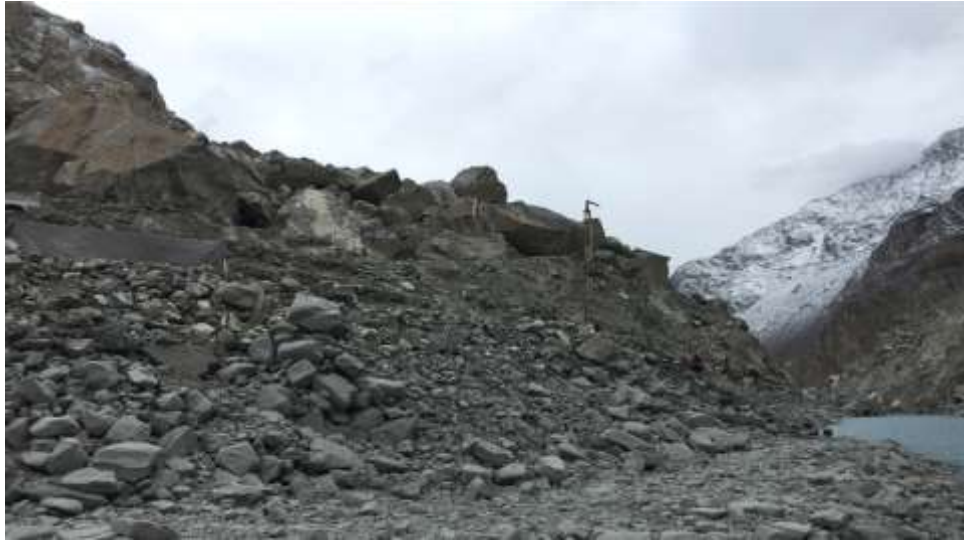
The surface geological mapping of the power tunnel alignment has been prepared at a scale of 1:1000 in field and presented at 1:2000 scale. It is proposed on the left side of Hunza River (**Photo 6.4**). It is observed during surface geological mapping that the sediment flushing channel has to be excavated through ABGM of slided mass (**DWG No: AFS-GE-297 & 298**)..

Slided mass covers an area of about 1 km and consist of huge volume of ABGM. One of the difficult and critical task is to stabilize the both side slopes along the sediment flushing channel. The large boulders of more than 25 m in length are present in slided mass. Benching is one of the best solution for such type of slope to stabilize. At some place, mashing or gabion may be helpful for slope stabilization.

**Photo 6-4 Intake Area of Sediment Flushing Channel.**

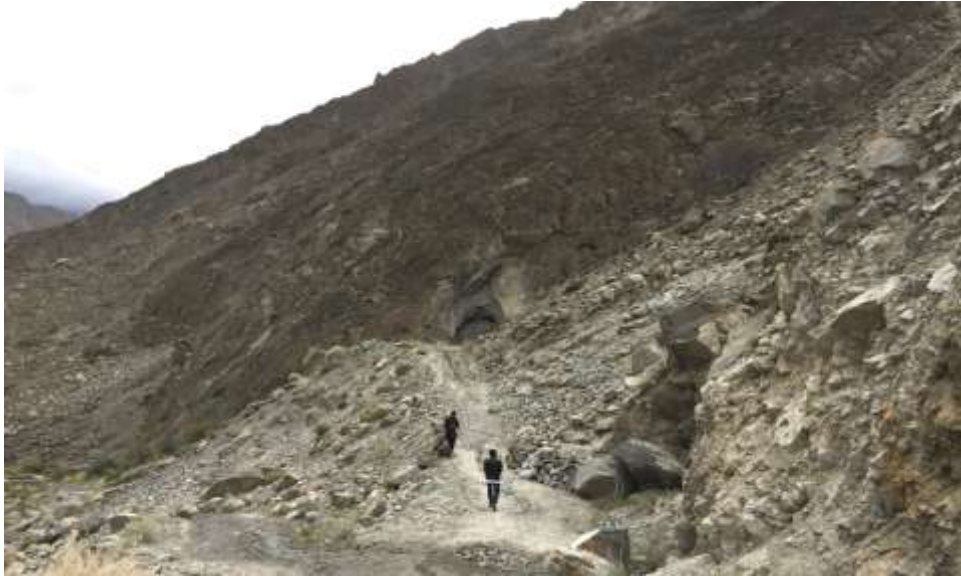
The surface geological mapping of the surge tank and penstock alignment have been carried out at a scale of 1:1000 in the field and presented at 1:2000 scale. It is proposed on the left side of Hunza River (**Photo 6-5**). It is observed during surface geological mapping that the granodiorite rock with granitic gneiss is exposed in surge tank area. It is moderately hard, sheared and highly jointed (**DWG No: AFS-GE-307**).

**Photo 6-5 Proposed Area for Surge Tank.**

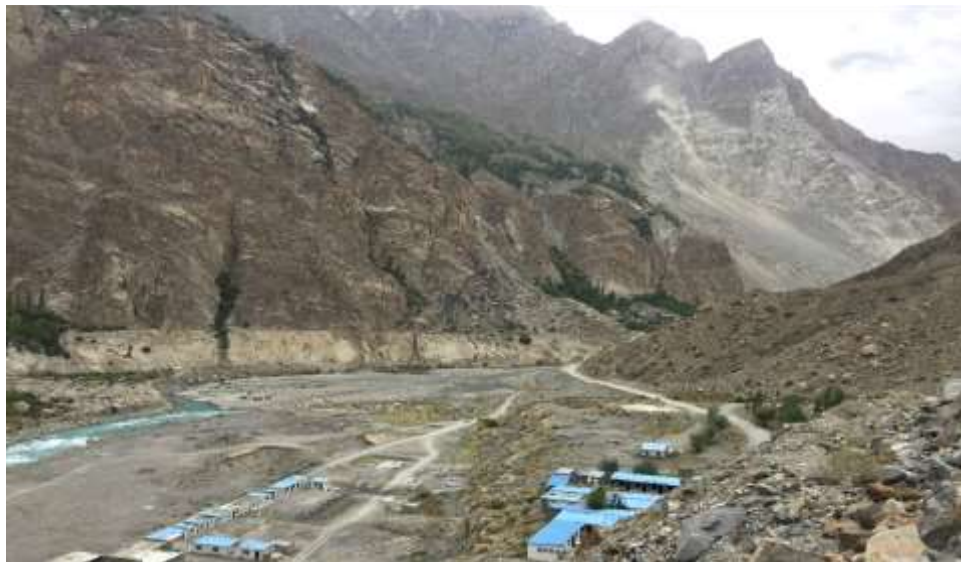
From surge tank 450 m long penstock with diameter of 3.6 m is proposed up to powerhouse. Piers will support penstock alignment. The foundation of piers will be laid on overburden material (**DWG No: AFS-GE-306 & 309**). The presence of clayey silt may create problem and might be excavated prior to establish foundation for piers (**Photo 6-6**).

**Photo 6-6 Proposed Alignment of Penstock.**

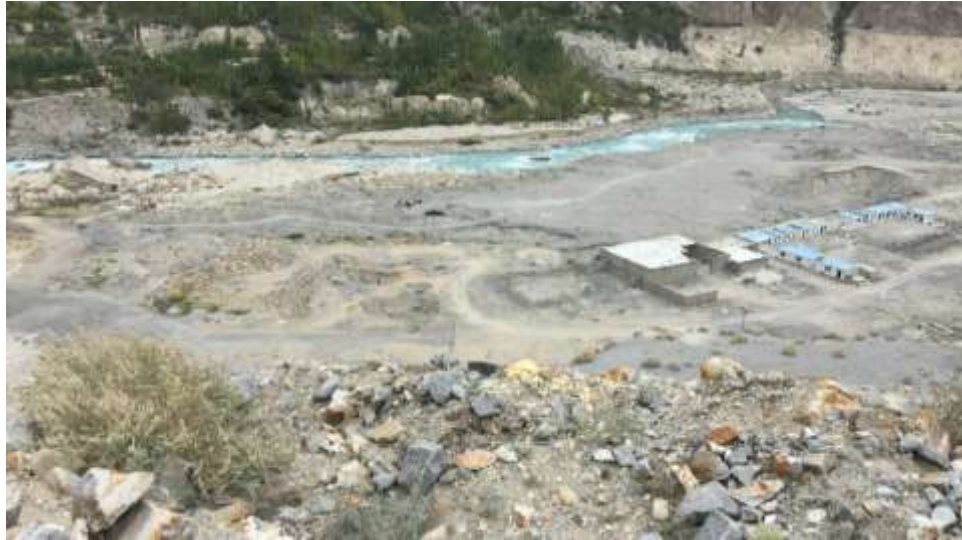
The surface geological mapping of the power tunnel alignment has been carried out at a scale of 1:1000 in the field and presented at 1:2000 scale. It is proposed on the left side of Hunza River on a flat area (**Photo 6-7**).

**Photo 6-7 Proposed Power House Area.**

It is observed during surface geological mapping that thick clayey silt has been deposited having depth of about 30 m as confirmed by drilling (BH-5 & BH-6). It is interbedded in upper layers by RBGM while pure clayey silt found in depth. It is deposited due to choking of Hunza River when Salmanabad slide occurred (DWG No: AFS-GE-309).. A geological X-section DD` has been established to estimate the sub surface conditions and presented as (DWG No: AFS-GE-315).

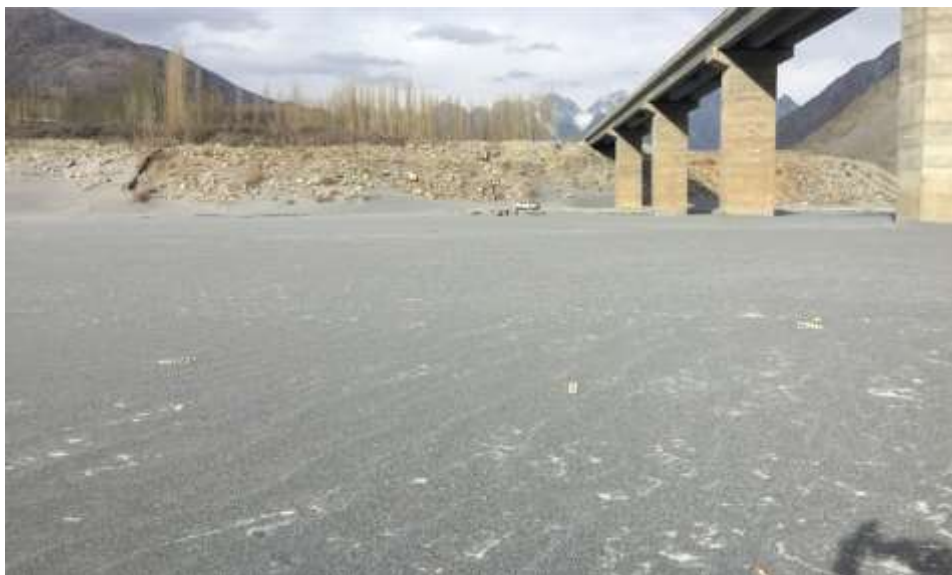
To fulfil the quantity of sand material during construction of ALHPP, ample quantity of this material is deposited in the tail area of Attabad Lake near Shishkat Bridge (**Photo 7-1**). A test pit TP-1 has been excavated, and samples have been collected for lab testing. Log of test pit is given in (**Volume 4A**). Gradation test, indicates that 99% sand with only 1% silt and clay is present (**Table 5-15 & 5-16**). The results of Accelerated Mortar Bar indicate minimum average expansion (0.039) for 28 days. Specific gravity and water absorption values also fall in permissible limits. The results of lab testing are provided in **Volume 4B**.

**Photo 7-1 Quarry Area Selected for Sand near Shishkat Bridge.**

The lab. test results show that it can favorably be used as sand quarry site for construction of ALHPP.

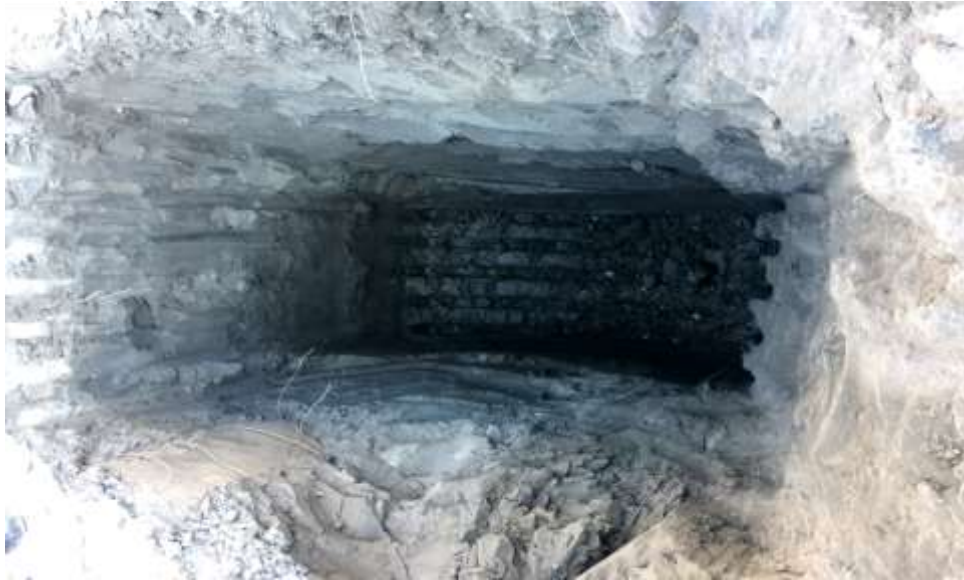
For fine aggregate (Clayey silt) 3 test pits 3x3x3m have been excavated to analyze the nature of material present in river bed. Two test pits TP-2 & TP-3 in helipad/powerhouse area and TP-10 near Klin area, near Ganesh Bridge, have been excavated to explore the subsurface geological conditions prevailing in the area (**Photo 7-2**). Both composite as well as block samples from each test pit have been collected for lab testing.

**Photo 7-2 TP-3, Excavated for Clayey Silt in P/H Area.**

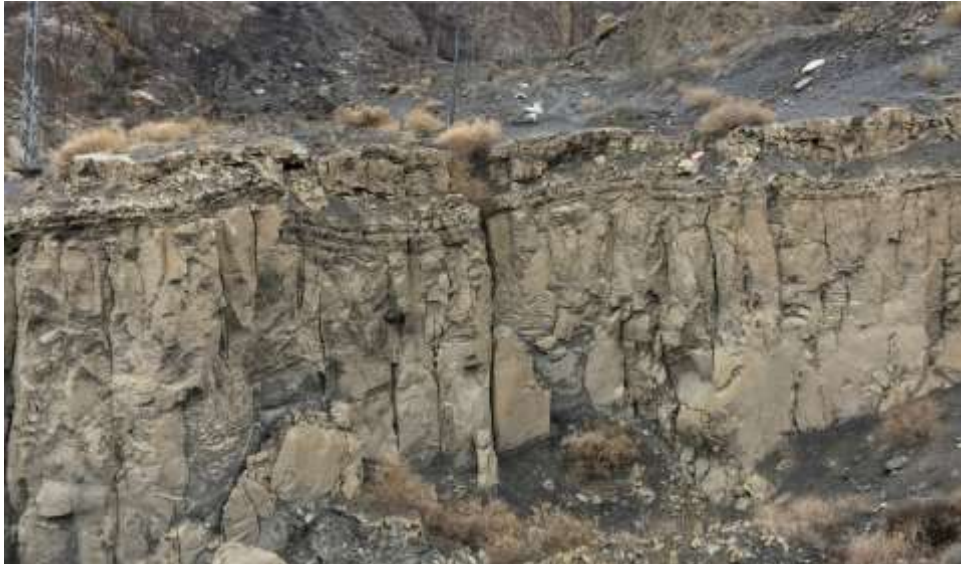
It indicates from lab test results that, clayey silt is present and can be used as blanket material to minimize the seepage. The ratio of silt and clay naturally present is 60 and 40% respectively (Table 5-16). It is present in adequate quantity in P/H area and near Ganesh Bridge.

**Photo 7-3 View of Clayey Silt in P/H Area.**

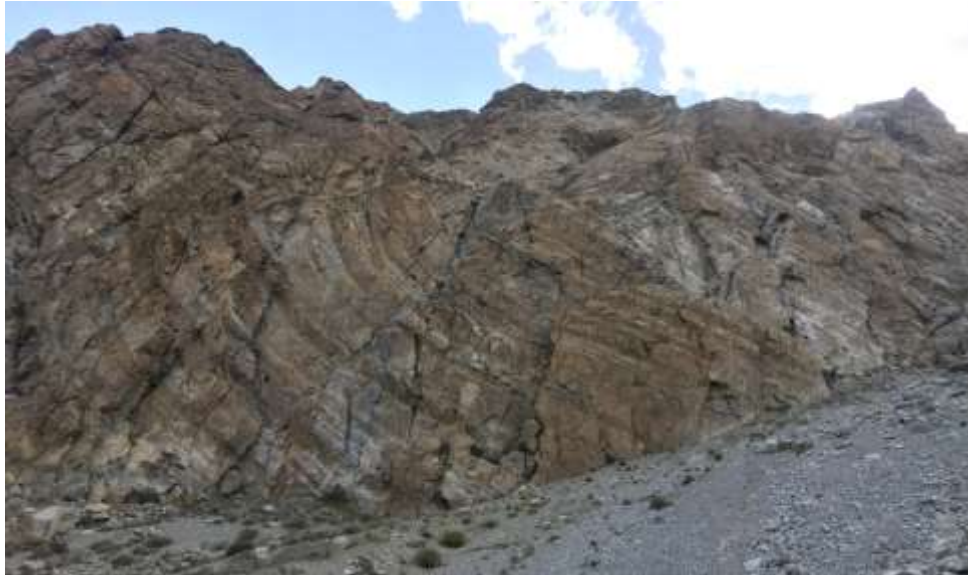
The laboratory test results indicate that the rock mostly consists of calcite with no alkali silica reaction and no alkali carbonate reaction. This material has no deleterious quartz and tests results fall in permissible limit; therefore, it can be used as coarse aggregate for concrete with Ordinary Portland Cement.

**Photo 7-4 Exposure of Marble in Passu Village Area.**

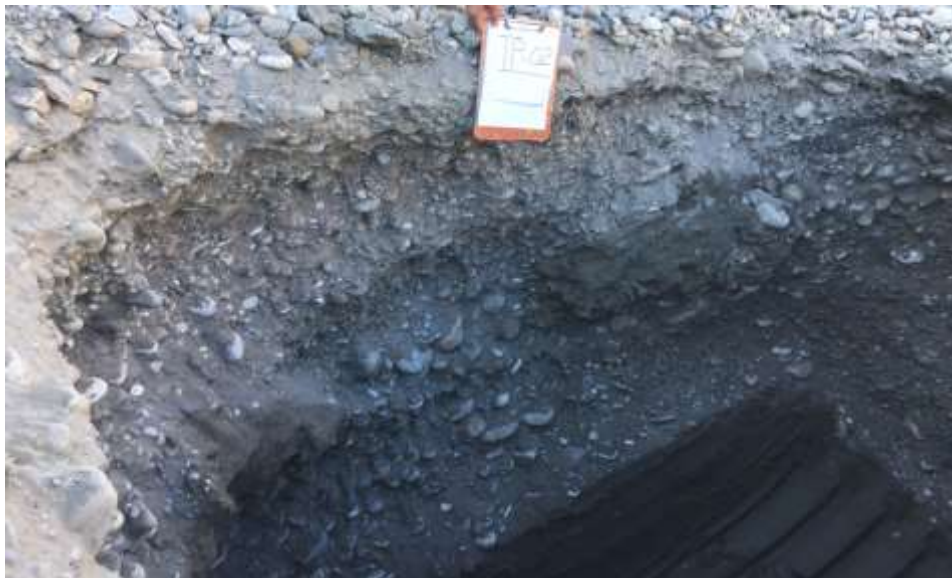
Large quantity of RBGM is deposited near old Chinese camp along old KKh route. Bulk sample from TP-2 has been collected and sent to lab for different tests **(Photo 7-5)**.

**Photo 7-5 View of RBGM in TP-2 at P/H Area.**

It consists of marble, granite, granitic gneiss, with some slate pieces. As per lab. test results, the material have specific gravity 2.78 with 0.33% water absorption. Los Angeles abrasion value with uniformity of wear is 0.20, crushing value is 27, and flakiness index is 21. Sulphate soundness value is 0.81 and average expansion for 28 days in accelerated mortar bar is 0.099, and point load index is 4.15 MPa (ch-5).

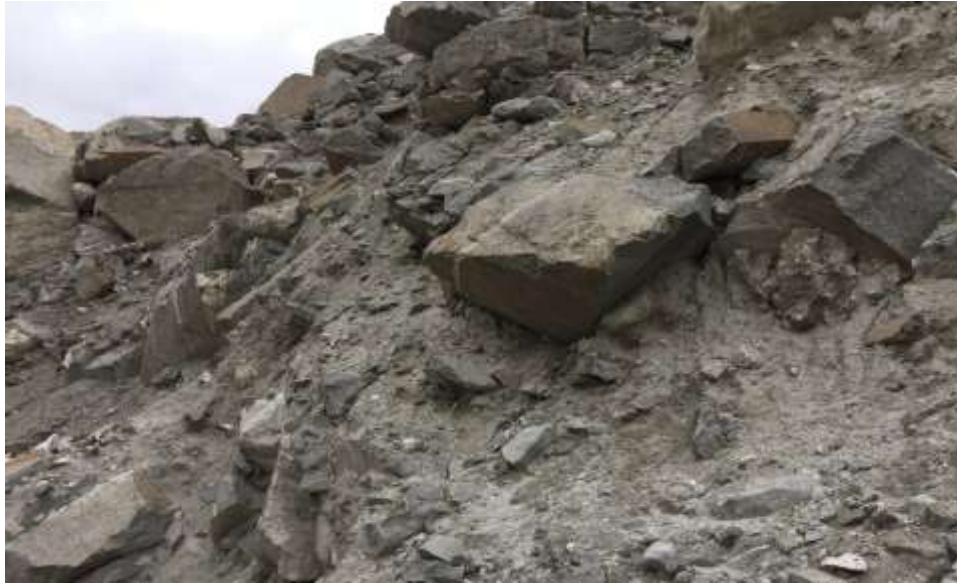
For protection works along slopes and structures, shoulder fill, construction of coffer dams, fill material of heterogeneous nature e.g. silty sand, sandy silt, gravelly sand etc. are available in river bed as well as in slided mass. These materials are present in ample quantities in the economic haulage of the Project Area.

**Photo 7-7 Fill Material (Boulder and Gravels) in Slided Mass.**

The test pits excavated in the powerhouse area / river beds show that large quantities of gravels and cobbles with subordinate sands are present. This materials satisfy the lab test program, therefore it might be used as fill material.

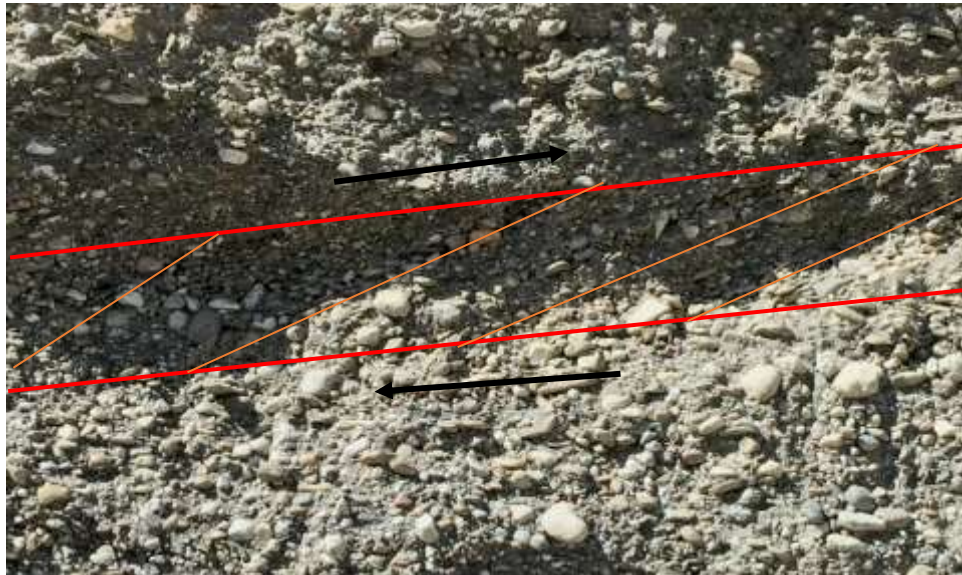
A large deposit of RBGM material is present along the right side slope of the river along KKH. This material consists mostly of gravel, cobble, and pebbles with subordinate sandy material. Some inclinations in these deposits have been observed along roof and sole beds. This inclination varies from 15° to 35° layer-by-layer (**Photo 8-1**).

**Photo 8-1 Inclined Gravel Layers under Effect of Shearing**

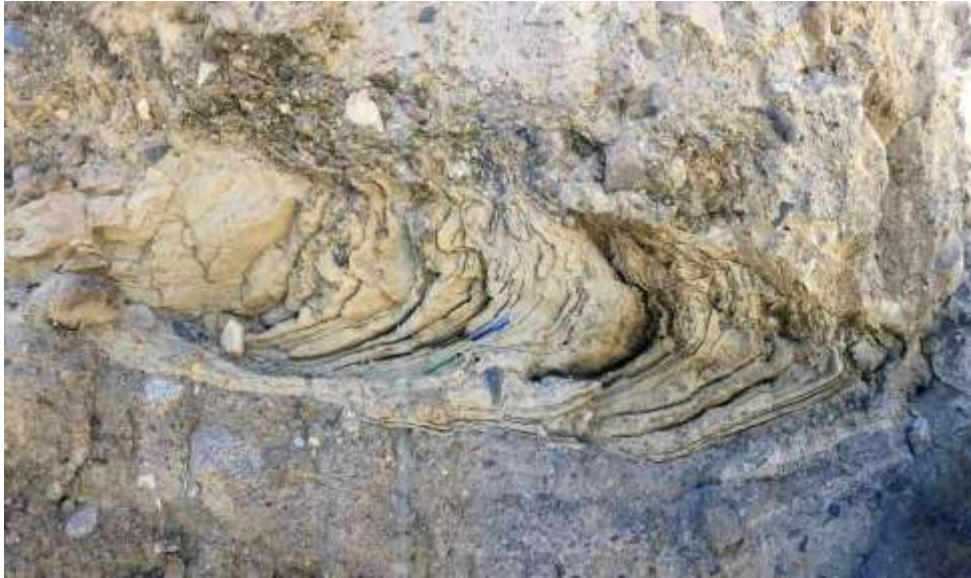
The clay deposits are overlain by morainic material of Batura Glacier. The clay deposits are tilted upward at an angle ranging from 10° - 15°. The area has undergone compressional regime, which uplifted the clay beds (**Photo 8-2**).

**Photo 8-2 Recumbent Fold Strata with Crenulation in Limbs in Clay Strata.**

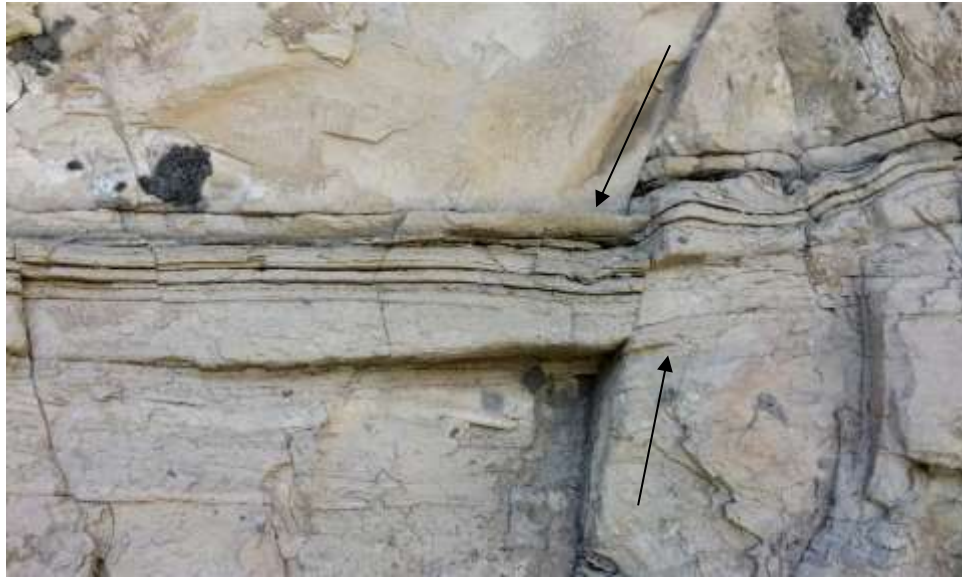
The relative movement of hanging wall block moves down relative to the footwall block, signposted the development of normal fault.

**Photo 8-4 Micro Fault in Clay Beds.**

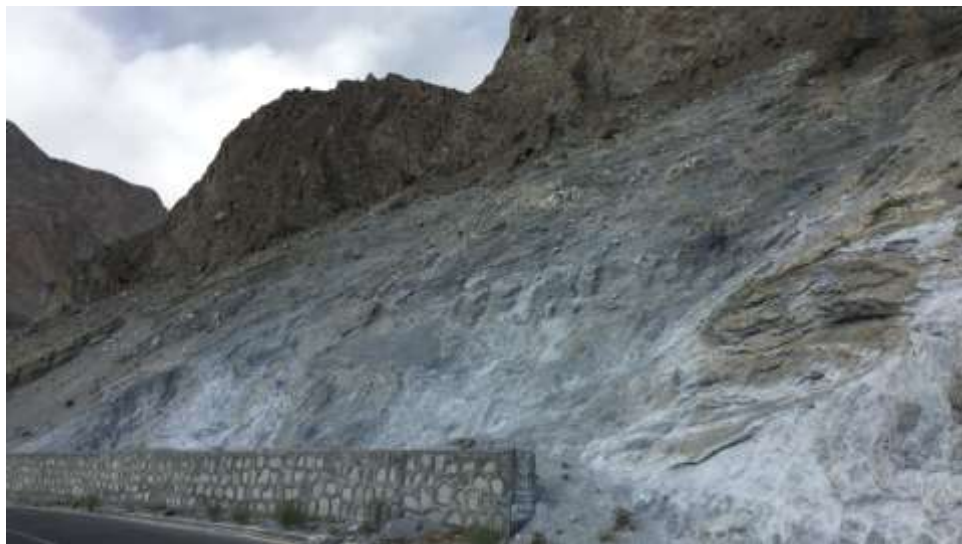
Just upstream of Hussaini village a large mass of ABGM and brecciated rock is exposed along the road. It is present in the alignment of thrust fault where crushed marble is in contact with Passu Slates. The faulted contact between slate and marble is well exposed along road (**Photo 8-6**).

**Photo 8-6 View of Brecciated Rock Upstream of Passu Village.**

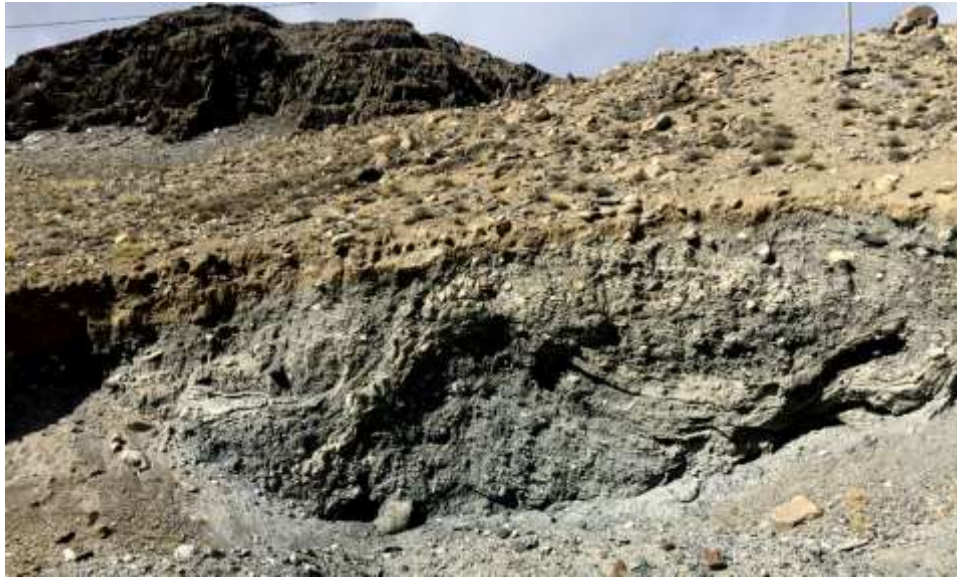
seems to be stable but in excavated portion, it is folded. Compressional forces are responsible for this deformation exposed at slope (**Photo 8-7**).

**Photo 8-7 View of Folded ABGM just Upstream of Passu Village.**

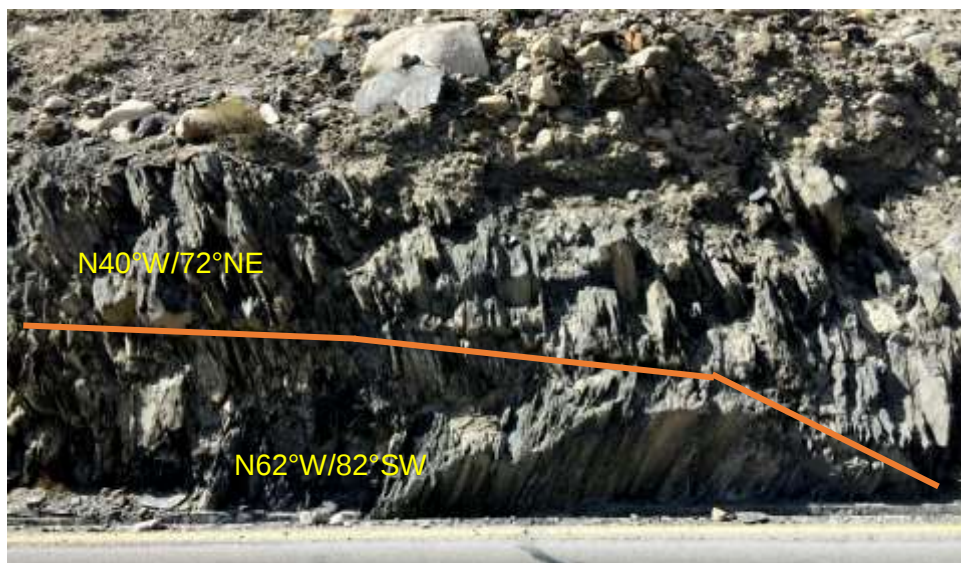
Rock (Passu Slates) is locally folded, some shear joints along which the cleavage plane (originally bedding planes) across shear joint has different dip values. The overall strike of slates is NW and dipping in NE but along this shear joint some movement took place and the value of dip changes from SW to NE (**Photo 8-8**). Change of sense of dip along the shear joint shows that some shear forces are active in the area. The developments of such joints indicate the brittle deformational style.

**Photo 8-8 Change of Dip along Shear joint.**

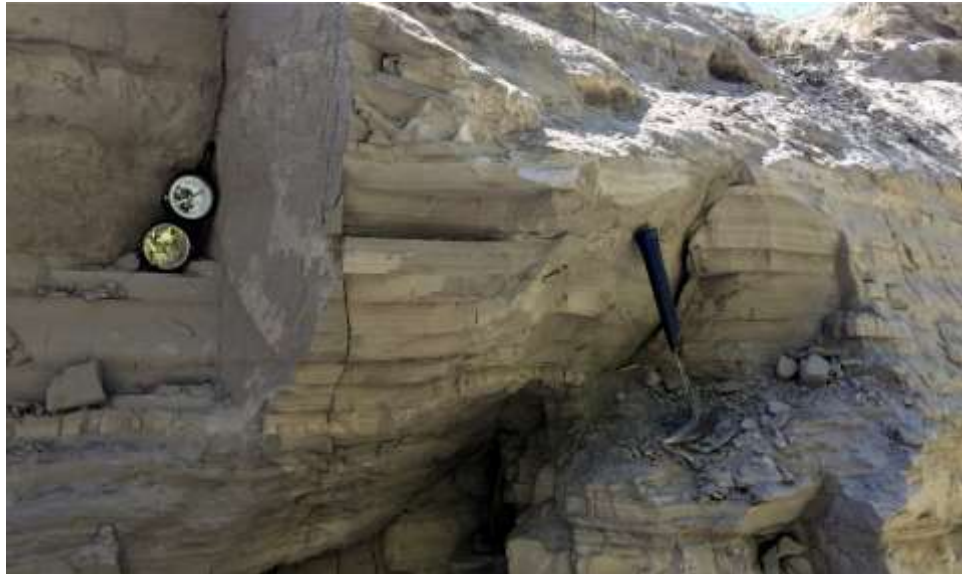
Both vertical and oblique joints can be seen in clayey silt at right side near Sarat Suspension Bridge. The strike and dip values of vertical and oblique joints are N38°W/87°NE and N32°E/63°SE respectively (**Photo 8-9**).

**Photo 8-9 View of Vertical and Oblique Joints in Clayey Silt at Sarat Village.**

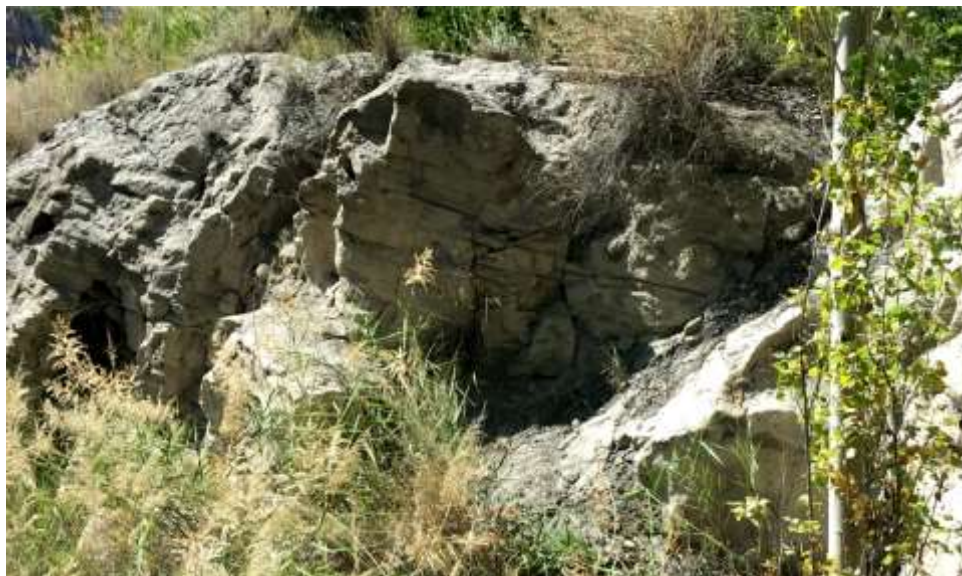
Clayey silt beds are striking N 80°E and dipping 18°NW at the left side of road to Sarat Village while at the right side of the road these beds have strike N 32°E and dipping 9°SE (**Photo 8-10 & 8-11**).

**Photo 8-10 Tiltiness in Clayey Silt Beds, Left Side of Road at Sarat Village.**

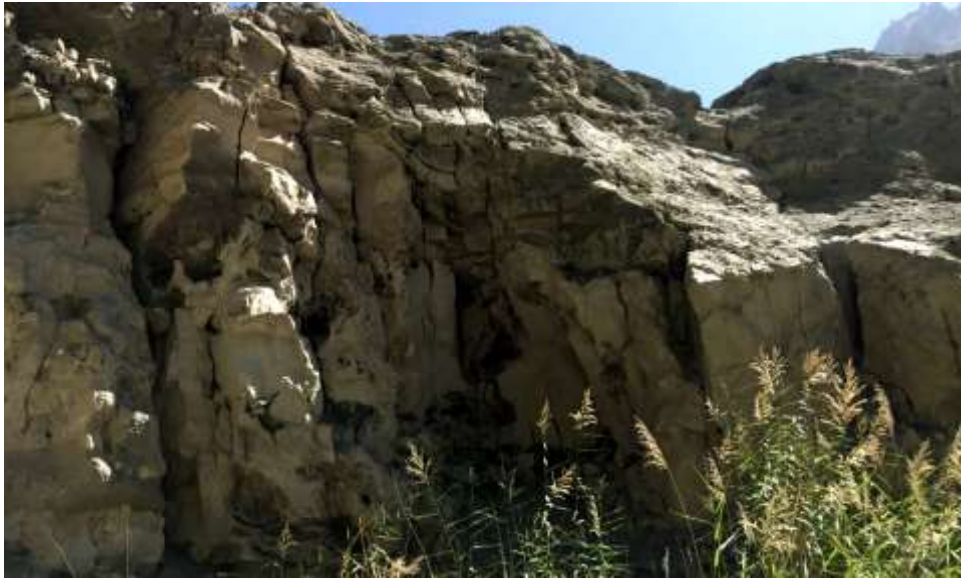
The strike of the beds is NE while the dip is in opposite direction, indicating that it forms some sort of antiform. Formation of antiform in recent deposits clearly indicates that lateral shear compressional force are operational in this area.

**Photo 8-11 Tiltiness in Clayey Silt Beds, Right Side of Road at Sarat Village.**

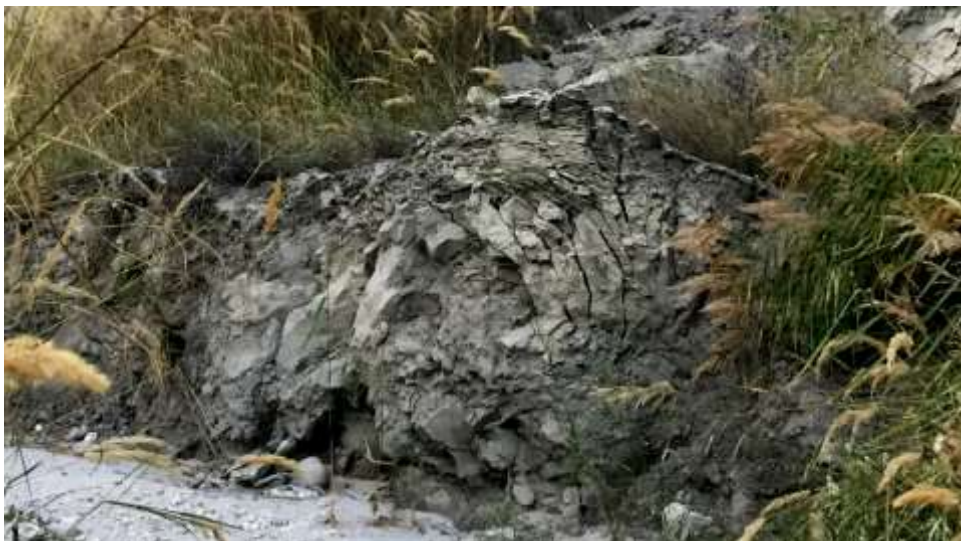
**Photo 8-12 Folded and Sheared Clayey Silt at Sarat Village.**

Folding, jointing, smearing and shearing of clayey silt (**Photo 8-12, 8-13, 8-14**) deposits show some lateral stresses are actively operating in this area. The active slides and rolling down of brecciated material from this slope indicate that it is tectonically active area.

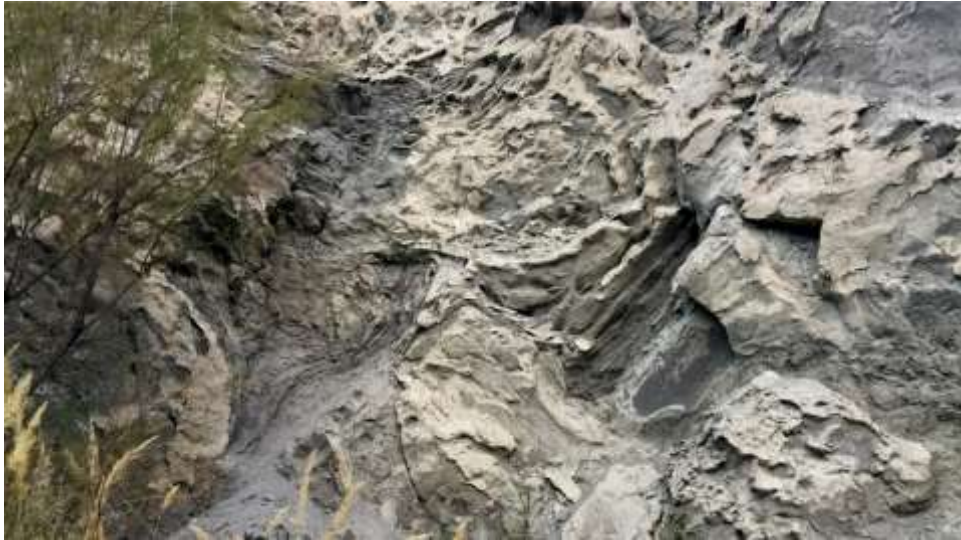
**Photo 8-13 Sheared and Smeared Clayey Silt at Sarat Village.**

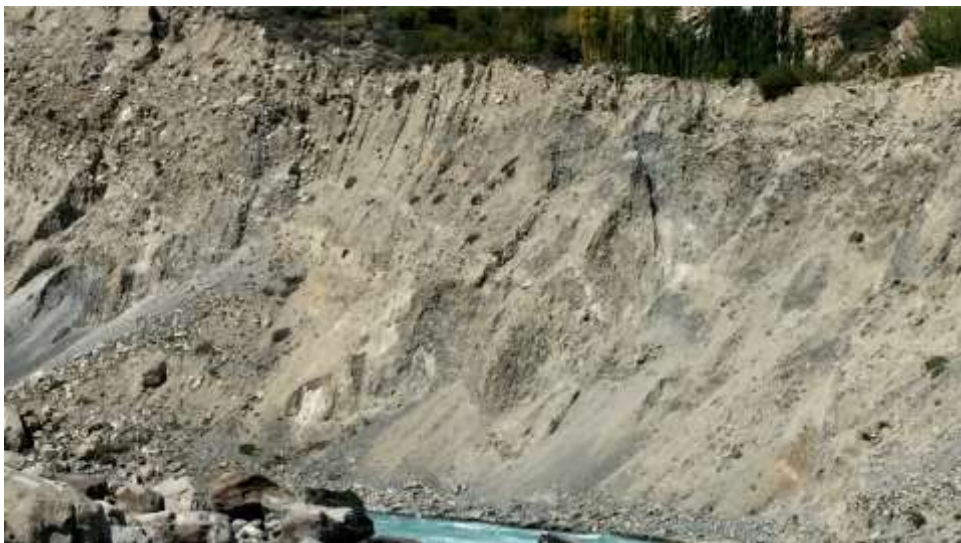
Just downstream of Sarat village near the Suspension Bridge, fault breccia is exposed along the river showing the alignment of fault.

**Photo 8-14 Fault Breccia just D/S of Suspension Bridge at Sarat Village.**

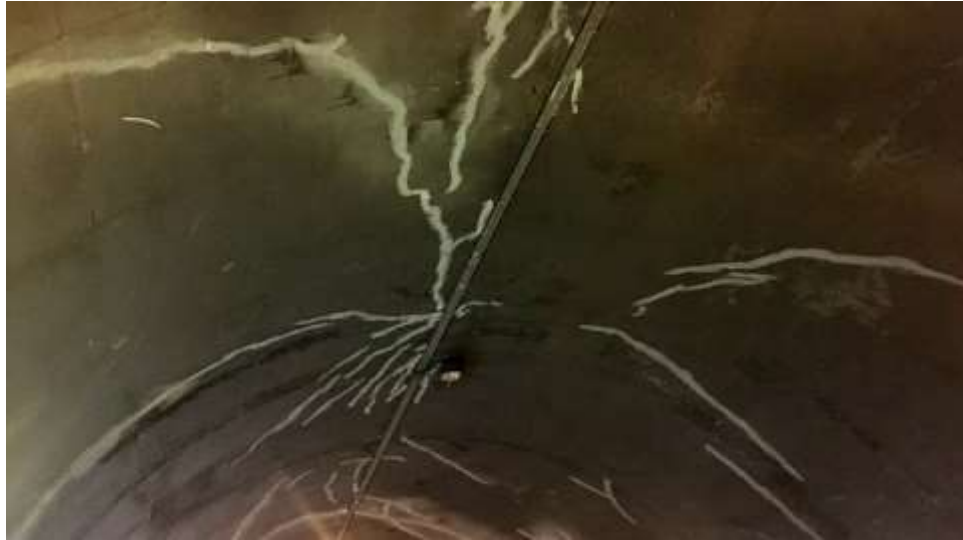
Many cracks/joints are going to develop in the concrete especially in crown area in tunnel-2. The pattern of the cracks indicates stress release and shear oblique joints (**Photo 8-15**).

**Photo 8-15 View of Recently Generated Joints Tunnel-2.**

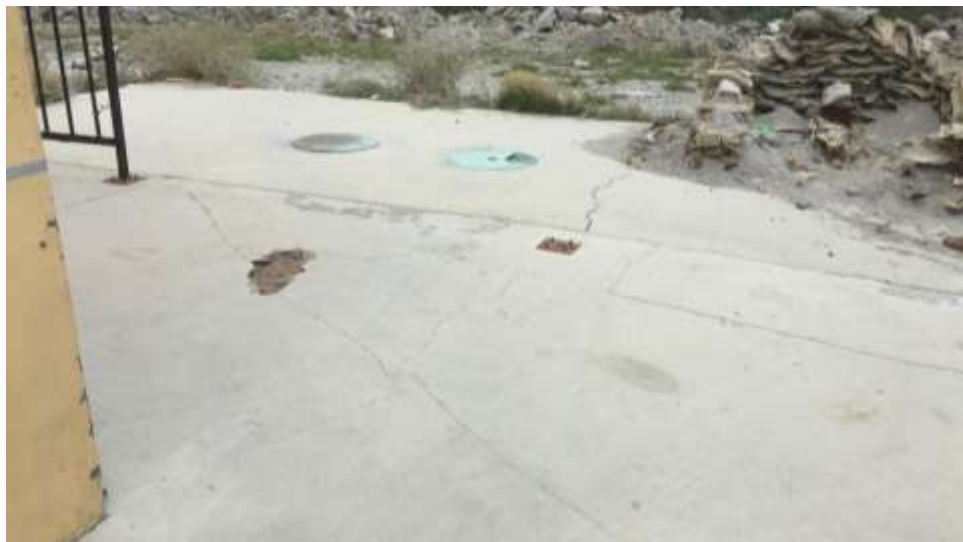
As far as geological condition is concerned, this portion of tunnel in is under influence of two faults (**DWG No: AFP- GE- 319**). Rock is highly crushed, rolling down of boulders is quite common along these active faults. The active tectonic forces are responsible for the development of fractures in this terrain. The same features can also be noted in concrete area in between tunnel 2 and 3 (**Photo 8-16**).

**Photo 8-16 View of Recently Generated Joints between Tunnel-2 & 3.**

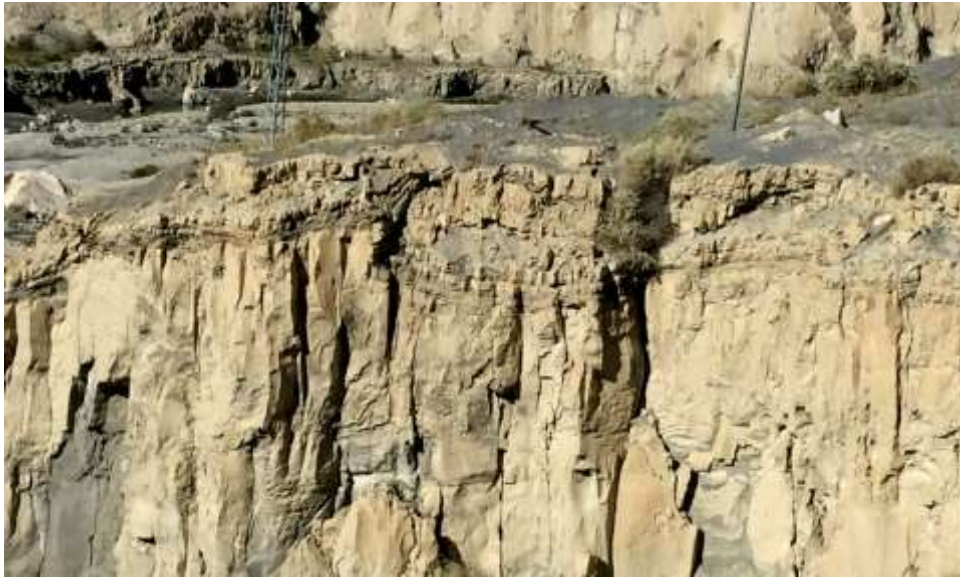
**Photo 8-17 Micro Thrust Fault in Clayey Silt Beds near Helipad.**

The relative movement of both blocks against fault plane indicates compressional environment, moved the hanging wall block upward **(Photo 8-17)**.

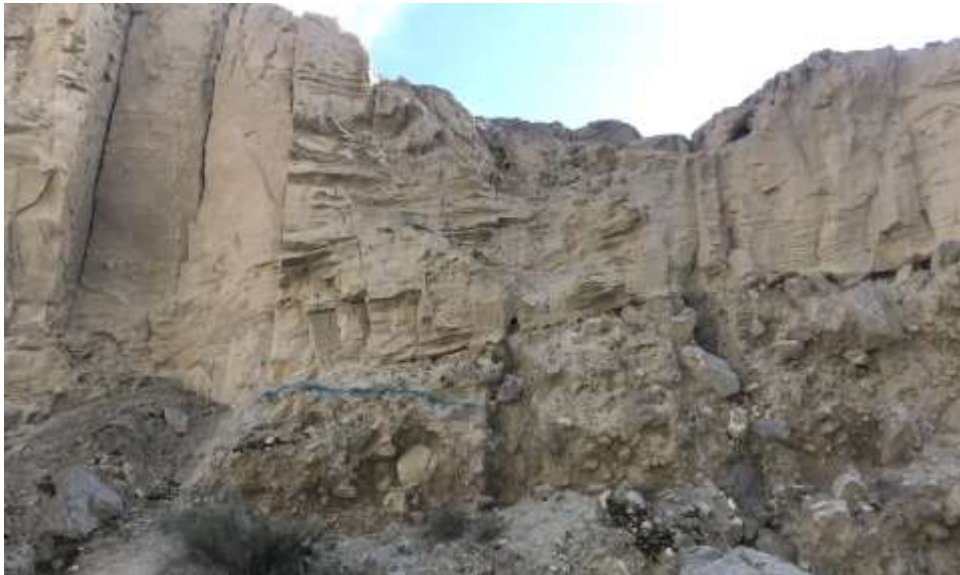
**Photo 8-18 Inclination of Clayey Silt near Helipad.**

The clayey silt beds are well exposed at the left side of Hunza River near Sarat Bridge. The clayey silt beds are well jointed and tilted upward at an angle ranging from  $10^{\circ}$  to  $15^{\circ}$  **(Photo 8-18)**. The inclinations of the beds in recent soil are active tectonic features.

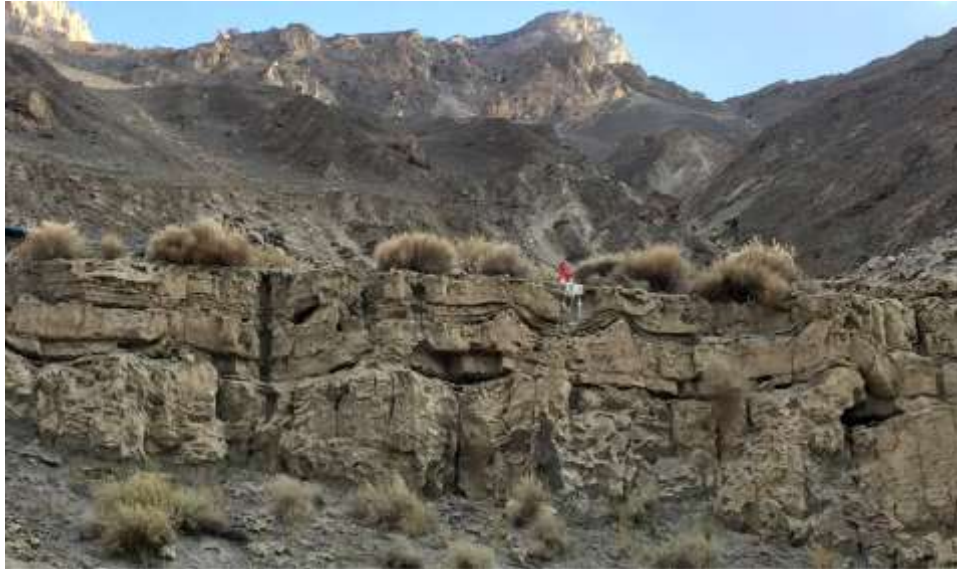
Near old Chinese Camp, at powerhouse area, the clayey silt is folded **(Photo 8-19)**. Folding in recently deposited clayey silt may be the result of slipping along fault plane under regional compressional shear forces.

**Photo 8-19 Folding in Clayey Silt near Helipad/Powerhouse Area.**

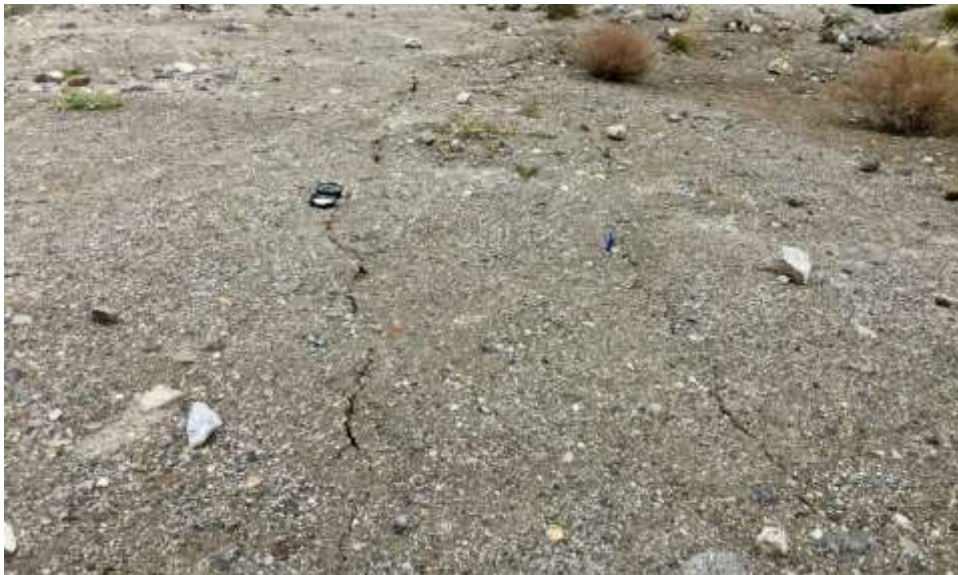
Near the SCO building, along old KKH, near tunnel-1, some cracks are going to develop in recently deposited material. The development of joints is mostly parallel in nature but occasional cross cutting joints also present (**Photo 8-20**).

**Photo 8-20 Development of Parallel Joints near SCO Building.**

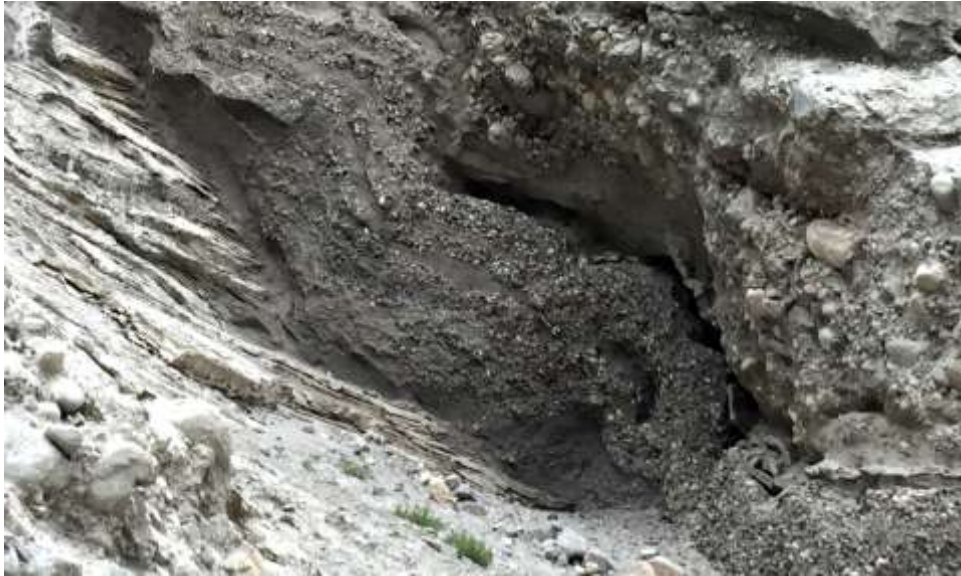
Just crossing the Murtazabad to Shahyar Bridge, a thick alluvial deposit consists of gravels, cobbles, pebbles interbedded with silty sand is exposed. This material moved upward against fault plane and formed fault bend fold (**Photo 8-21**).

**Photo 8-21 Inclination in Clay Silt and Gravels.**

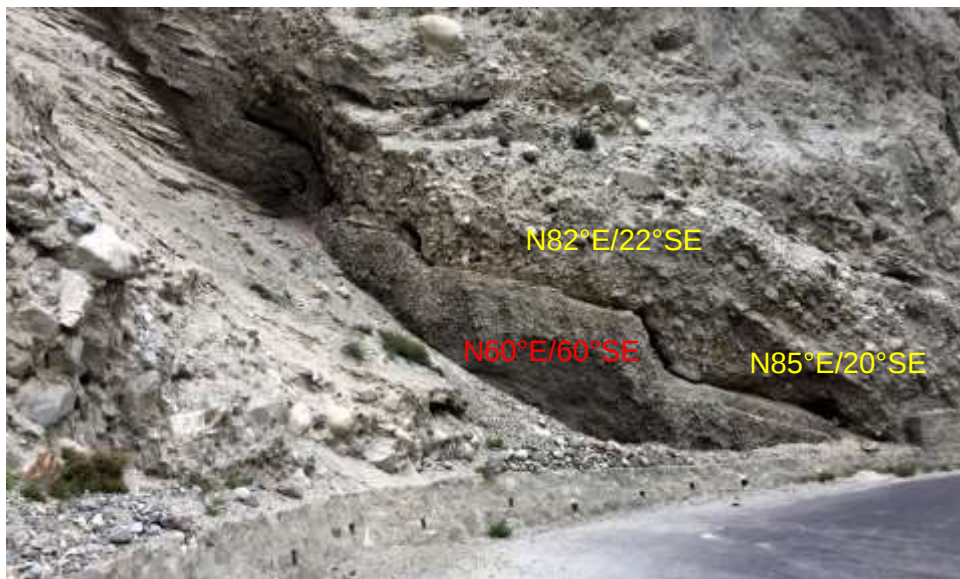
The beds are tilted at an angle of 22° to 30°. Many micro fault in sand beds have been observed in hinge area of the fold. The ramp and flat geometry have NE striking and dip SE **(Photo 8-22)**.

**Photo 8-22 Ramp and Flat Geometry along Fault.**
