**PAKISTAN**  
**WATER AND POWER DEVELOPMENT AUTHORITY**  
**ATTABAD LAKE HYDROPOWER PROJECT**  
**FEASIBILITY STUDY**

**VOLUME 3**  
**GEOLOGICAL AND GEOTECHNICAL**  
**STUDIES**

June 2021

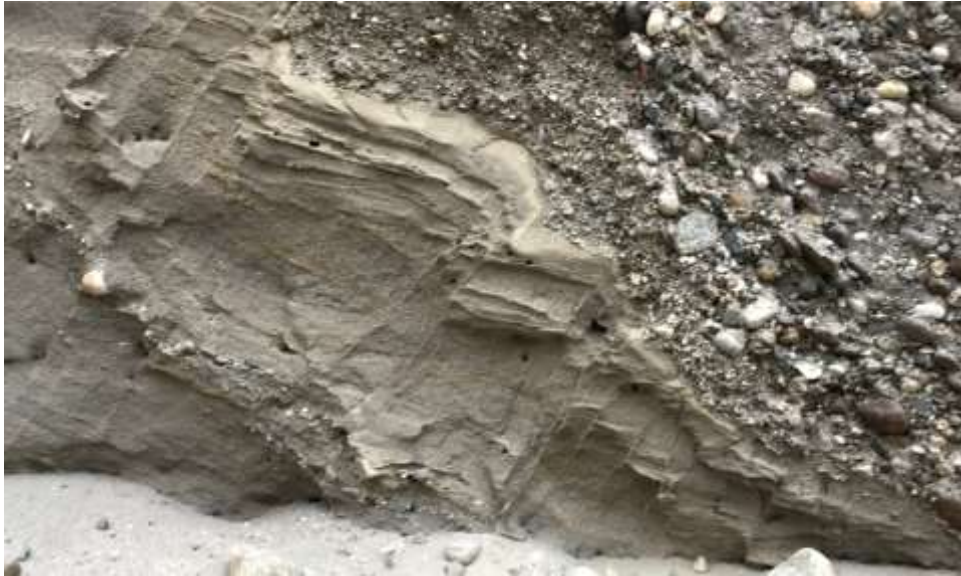
Some micro faults have been observed in this alluvium. Step faulting on micro level is well preserved in sandy material **(Photo 8-23)**. This alluvium is overlain by morainic material. Same joint pattern is going to be develop in it. Some open joints ranging from 10 cm to 150 cm have been observed there. All these features indicate that the tectonic forces are active in this area.

**Photo 8-23 Development of Micro Faults in Sand.**

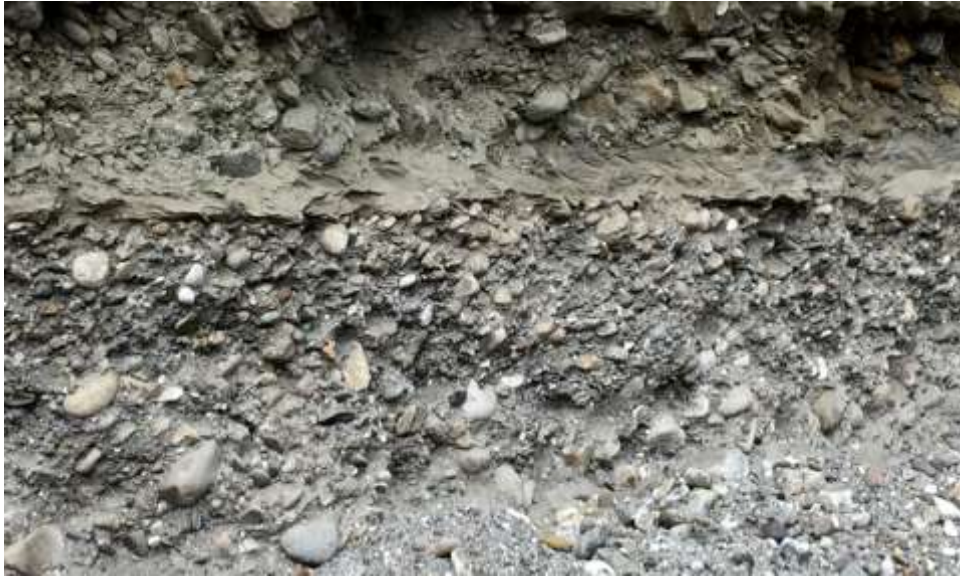
Upward inclination of 6° in recent RBGM is measured along the road (**Photo 8-24, 8-25**).

**Photo 8-25 Inclination in RBGM in Tashot Village along Road.**
